HARTZELL PROPELLER INC.

ALERT SERVICE BULLETIN

HC-ASB-61-313

Propeller - Counterweight Slug Bolt Inspection

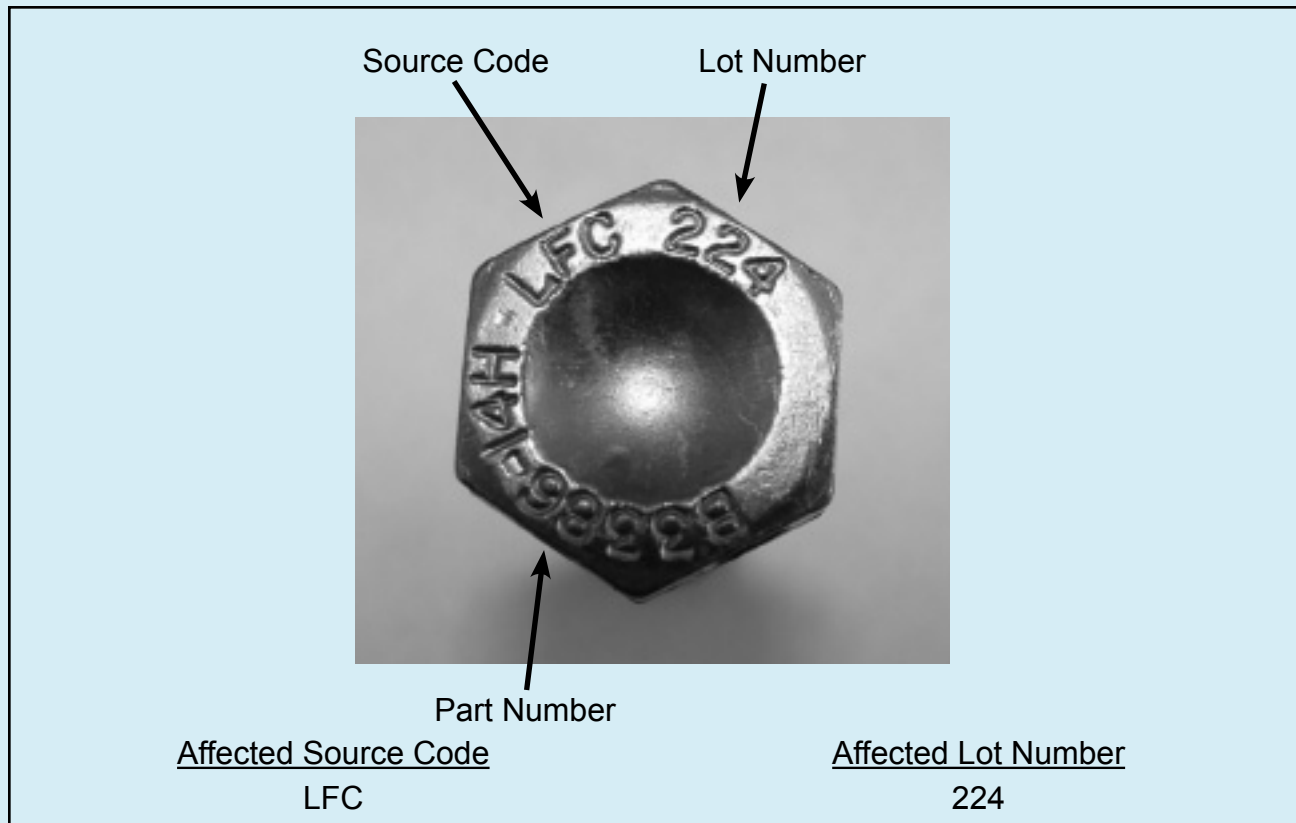
Counterweight Slug Attachment Bolt Identification
Figure 1

- (1) Instances of bolt failure have been reported on the B-3386-14H counterweight slug attachment bolt from the LFC manufacturing lot 224, causing the counterweight slug to separate from the propeller.
- (2) The failure of the bolt caused the bolt head to separate from the bolt grip.
- (3) The failure of the bolt was because of a manufacturing defect in the bolt.
- (4) Regulatory action (Airworthiness Directive) is expected on this subject.

- (a) Inspect each B-3386-14H counterweight slug attachment bolt on the propeller for the affected LFC manufacturing lot. See Figure 1.
 - 1 Bolts marked from another source code or lot number other than 224 are not affected by this Alert Service Bulletin.
 - 2 If only one counterweight slug attachment bolt on a counterweight slug is from the affected LFC manufacturing lot 224, both bolts may require replacement.
 - 3 Visually inspect all LFC manufacturing lot 224 counterweight slug attachment bolts for the following obvious signs of failure:

- a An obviously bent shaft.
- b Any obvious cracking.
- c The head of the bolt is separated from the shaft.

- c Install one new B-3386-14H bolt that is not from LFC manufacturing lot 224 in the hole where the original bolt has been removed.
 - d Using a calibrated torque wrench, torque the bolt to 36 ft-lb (48.8 N•m) dry torque.
